**Horizon Home Inspections, LLC**

## **Confidential Inspection Report**

**123 Main St.  
Somecity Ohio 45454**

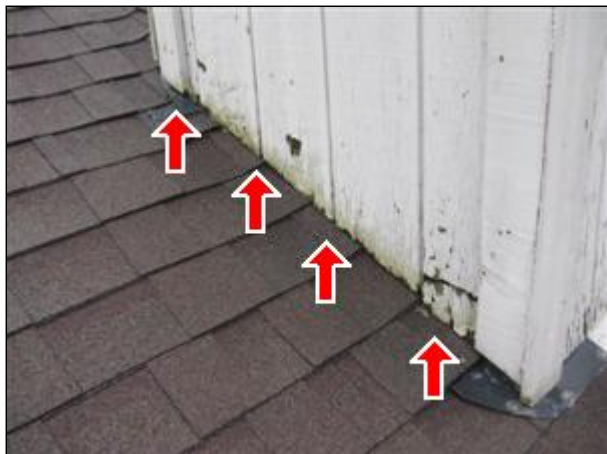
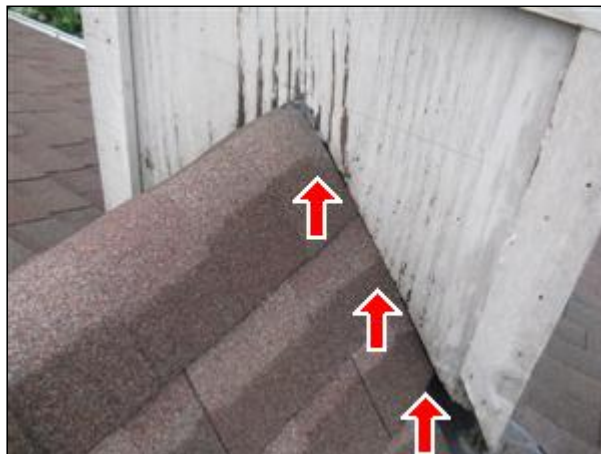
1.1 Picture 1

1.1 (1) The chimney is not flashed properly. The wood cladding around the chimney is in direct contact with the shingles, resulting in moisture penetration. The wood is soft and flakes off easily. This damage should be repaired. A qualified roofing contractor should inspect further and correct as needed.

(1) The chimney is not flashed properly. The wood cladding around the chimney is in direct contact with the shingles, resulting in moisture penetration. The wood is soft and flakes off easily. This damage should be repaired. A qualified roofing contractor should inspect further and correct as needed.

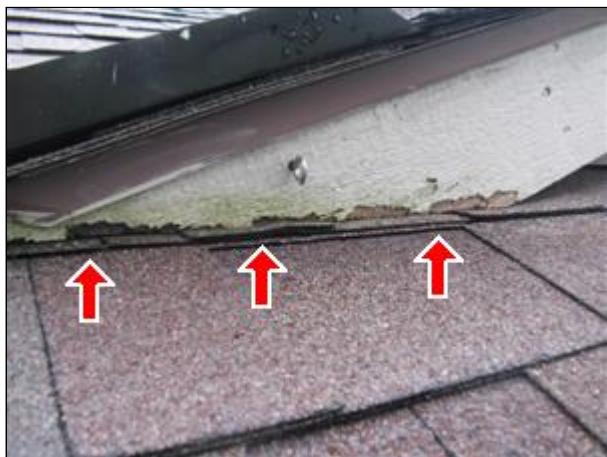
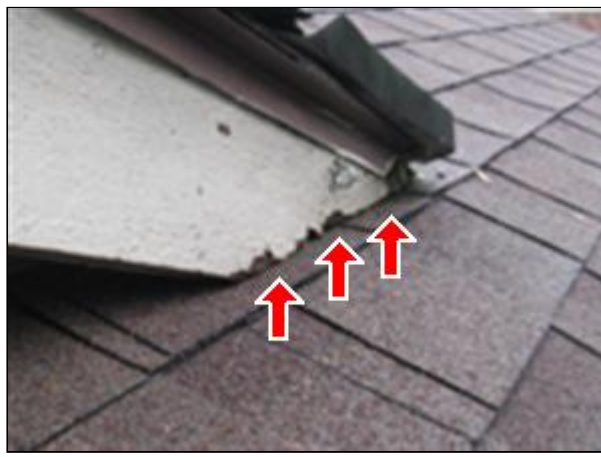
1.1 Picture 3

1.1 (2) The wood trim at the base of the front peak of the roof is in direct contact with the shingles, resulting in moisture penetration. The wood has a spongy texture and flakes off easily. This damage should be repaired. A qualified roofing contractor should inspect further and correct as needed.

(2) The wood trim at the base of the front peak of the roof is in direct contact with the shingles, resulting in moisture penetration. The wood has a spongy texture and flakes off easily. This damage should be repaired. A qualified roofing contractor should inspect further and correct as needed.

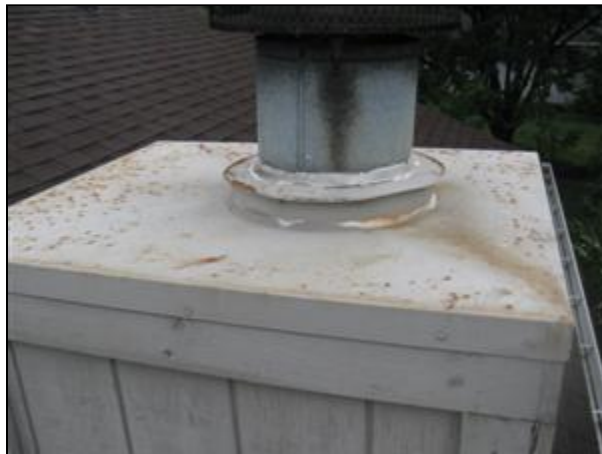
1.2 Picture 1

1.2 Surface rust on chimney crown was noted. Recommend sealing to preserve the life of the crown.

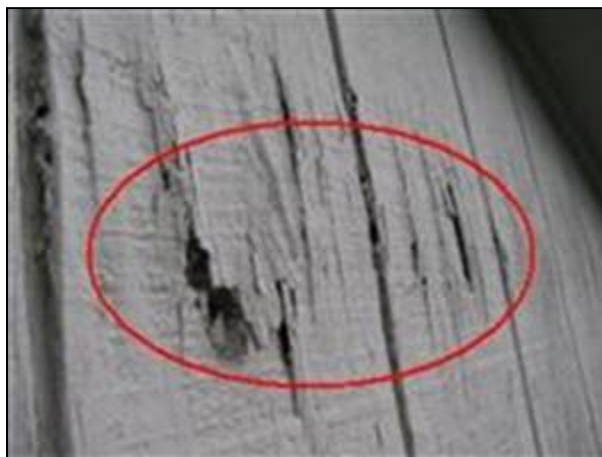
2.0 Picture 1

2.0 (1) The wood siding at the north side of home is deteriorated in various areas. Further deterioration can occur if not corrected. A qualified person should repair or replace as needed.

(1) The wood siding at the north side of home is deteriorated in various areas. Further deterioration can occur if not corrected. A qualified person should repair or replace as needed.

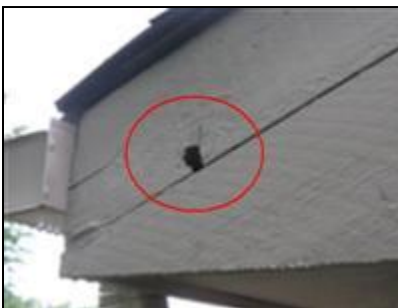
2.0 Picture 2

2.0 (2) The wood trim has a 1-inch diameter hole at the Northwest corner of the home, leaving unfinished wood exposed. Further deterioration can occur if not corrected. A qualified person should repair as needed.

(2) The wood trim has a 1-inch diameter hole at the Northwest corner of the home, leaving unfinished wood exposed. Further deterioration can occur if not corrected. A qualified person should repair as needed.

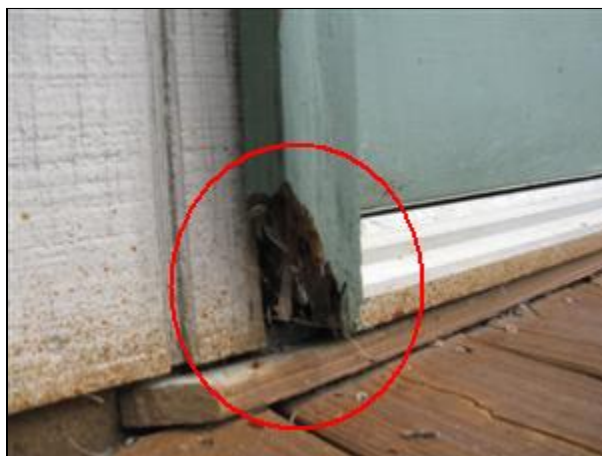
2.0 Picture 3

2.0 (3) The wood trim at the north side of detached garage(next to the entry door) is deteriorated. Further deterioration can occur if not corrected. A qualified person should repair or replace as needed.

(3) The wood trim at the north side of detached garage(next to the entry door) is deteriorated. Further deterioration can occur if not corrected. A qualified person should repair or replace as needed.

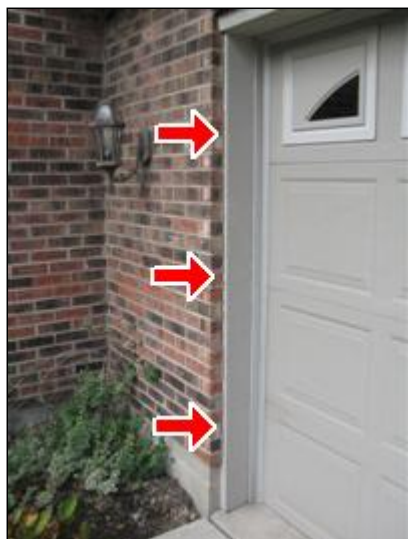
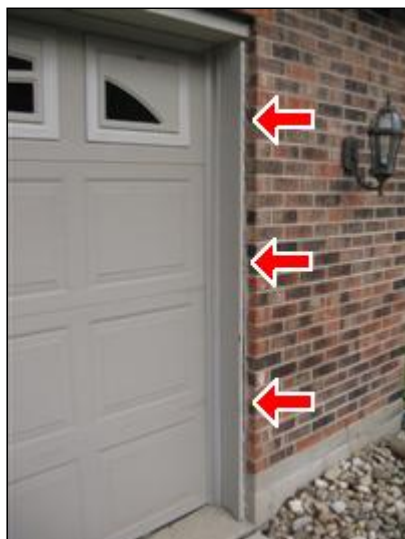
2.0 Picture 4

2.0 (4) The caulk between the brick and wood along both sides of the garage is dried and cracked. As a result, water is getting in behind the wood and deteriorating it. This is at a more advanced stage on the right side. Do no less than recaulk to prevent further deterioration.

(4) The caulk between the brick and wood along both sides of the garage is dried and cracked. As a result, water is getting in behind the wood and deteriorating it. This is at a more advanced stage on the right side. Do no less than recaulk to prevent further deterioration.

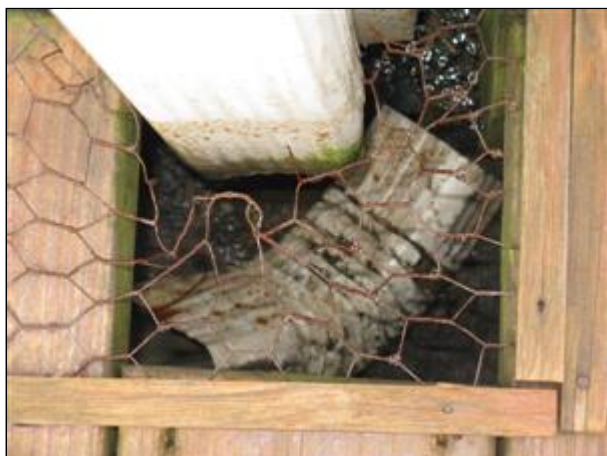
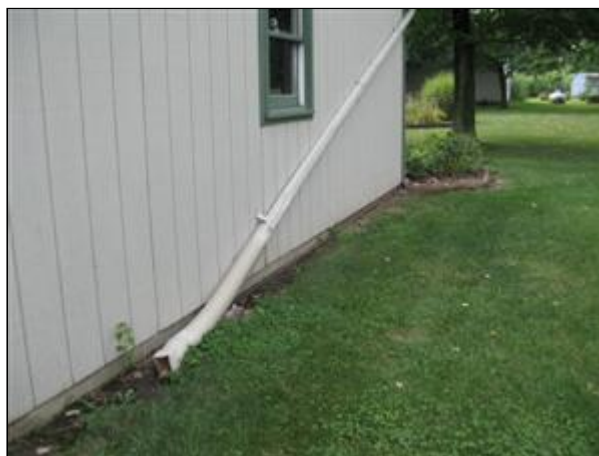
2.4 Picture 1

2.4 The downspouts at southwest corner of patio room and south side of detached garage need extensions to carry water away from the foundation. Lack of extensions can lead to water problems. I recommend adding extensions to drain water at least 4 feet away from foundation walls.

The downspouts at southwest corner of patio room and south side of detached garage need extensions to carry water away from the foundation. Lack of extensions can lead to water problems. I recommend adding extensions to drain water at least 4 feet away from foundation walls.

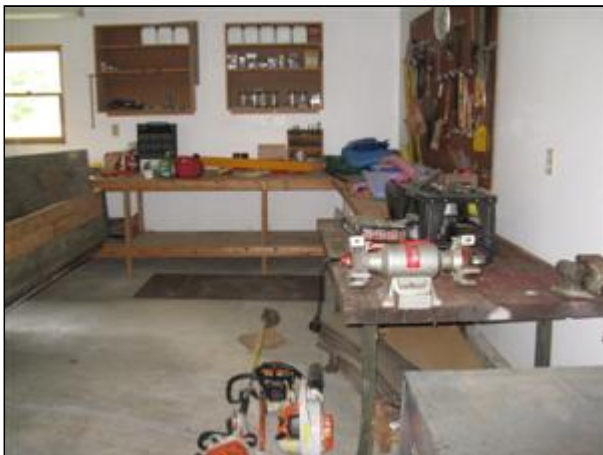
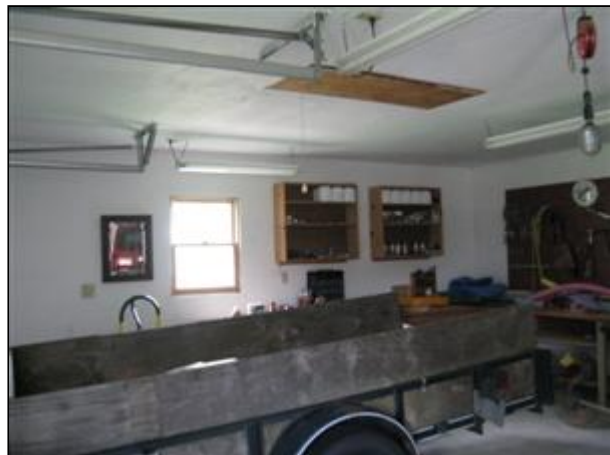
3.1 Picture 1

**3.1** Stored items are placed along the walls and most of the floor in attached and detached garages which prevent a full, unobstructed examination of the walls and floors of the interior portion of the garage. DO NO LESS than re-inspect once the materials have been removed.

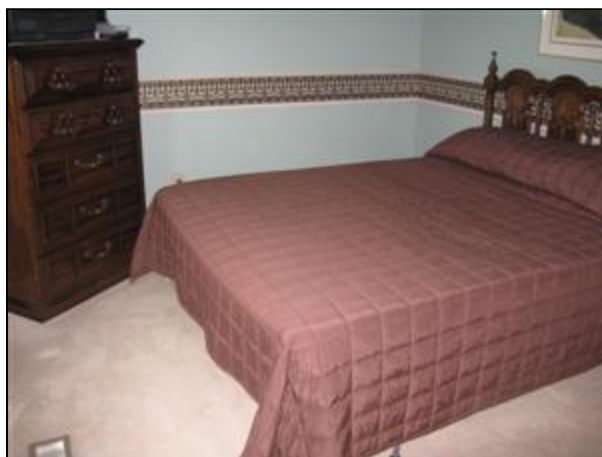
4.1 Picture 1

4.1 Parts of the front corner bedroom walls were not visible due to furniture.

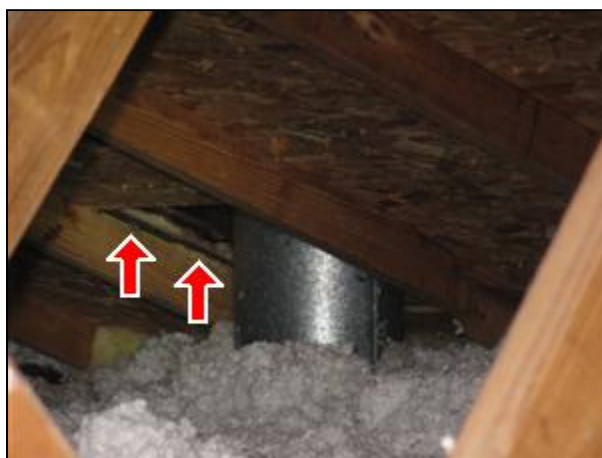
5.4 Picture 1

**5.4** There appeared to be some moisture penetration through the roof structure surrounding the chimney flue. I could not confirm this due to there being no access to the area. I recommend having a licensed roofer investigate further and make any repairs necessary.

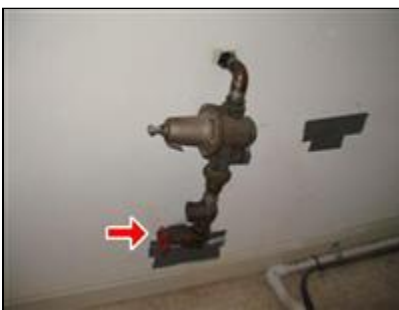
6.3 Picture 1

6.3 The main shut off is the knob located beside the water heater. This is for your information.

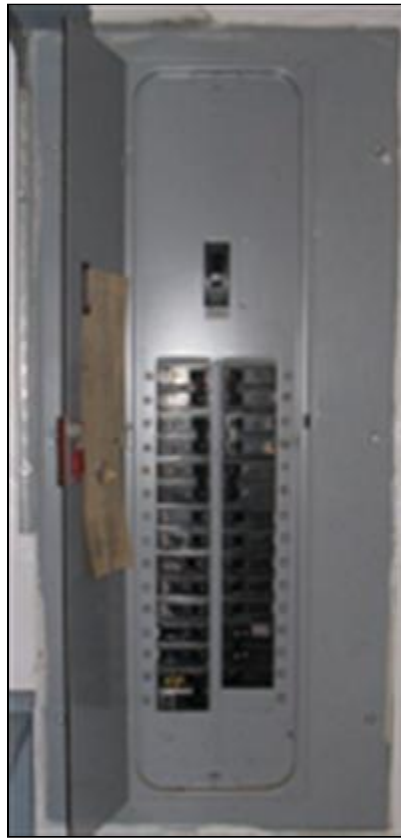
7.1 Picture 1

7.1 The main panel has circuit breakers that are mislabeled. I recommend updating.

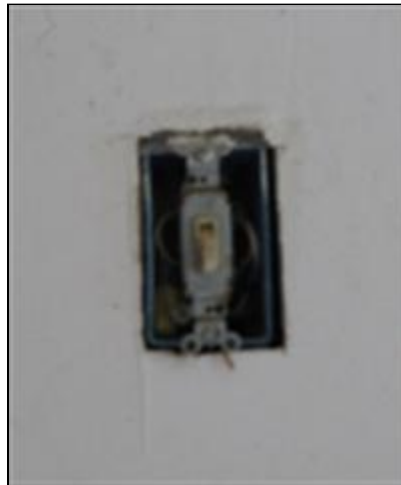
7.3 Picture 1

7.3 (1) The light fixture is missing cover at the detached garage. This is a safety issue that needs to be corrected. A qualified licensed electrical contractor should correct as needed.

(1) The light fixture is missing cover at the detached garage. This is a safety issue that needs to be corrected. A qualified licensed electrical contractor should correct as needed.

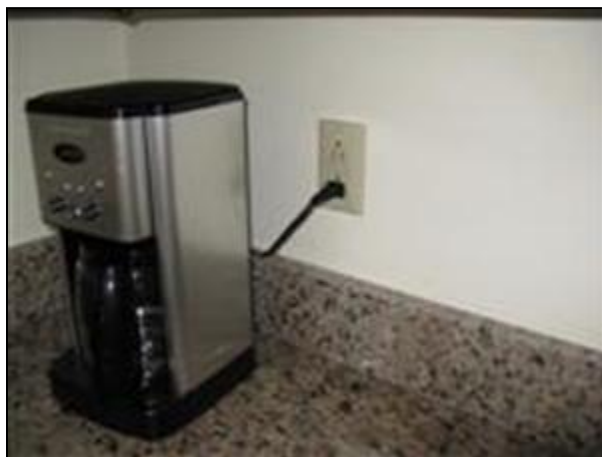
7.4 Picture 1

7.4 (1) One GFCI (Ground Fault Circuit Interrupter) outlet at the Kitchen won't trip when tested. This is a safety issue that needs to be corrected. A qualified licensed electrical contractor should correct as needed.

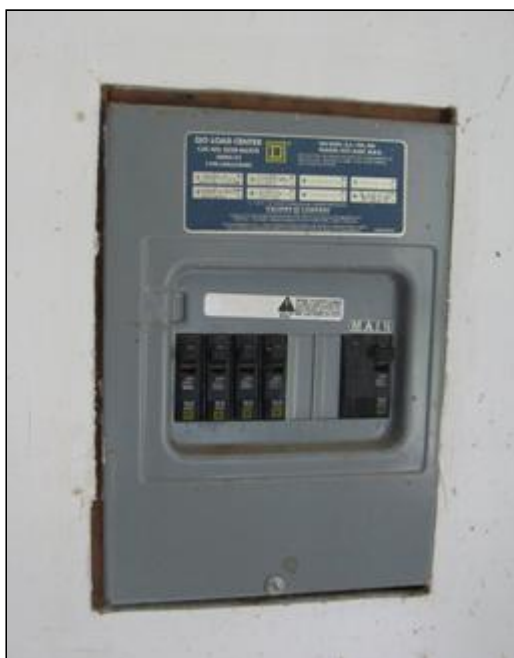
7.6 Picture 2 Subpanel

The sub panel box is located at the detached garage.

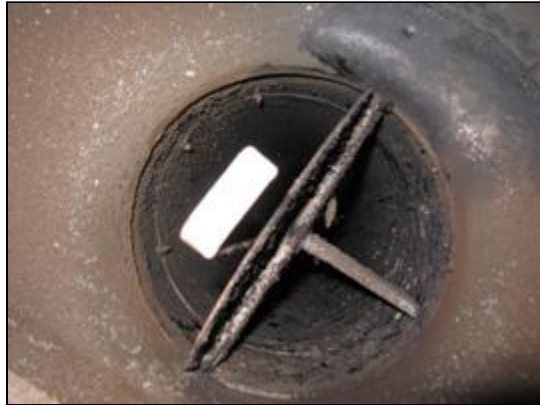
8.5 Picture 1

**8.5** The metal liner in chimney for fireplace in the family room appears to have some rust. Only about 15% of the liner was visible. A qualified chimney sweep should investigate further prior to use.

The metal liner in chimney for fireplace in the family room appears to have some rust. Only about 15% of the liner was visible. A qualified chimney sweep should investigate further prior to use.

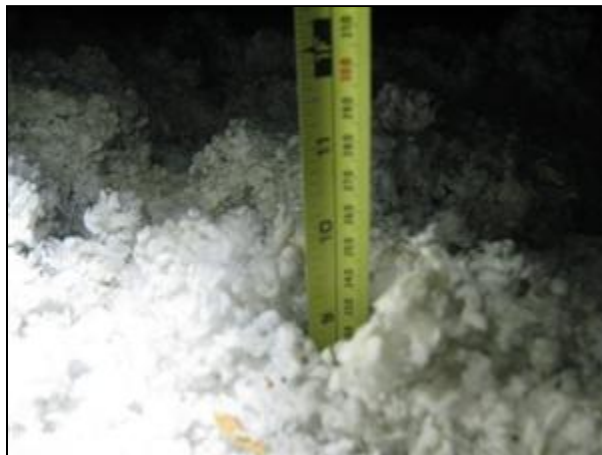
9.0 Picture 1

**9.0 (1)** An insulation R-value of 39 in the attic is recommended. There are approximately 10 inches of insulation in the attic, resulting in an R-value of 30. I recommend adding at least 3 inches of insulation.

(1) An insulation R-value of 39 in the attic is recommended. There are approximately 10 inches of insulation in the attic, resulting in an R-value of 30. I recommend adding at least 3 inches of insulation.

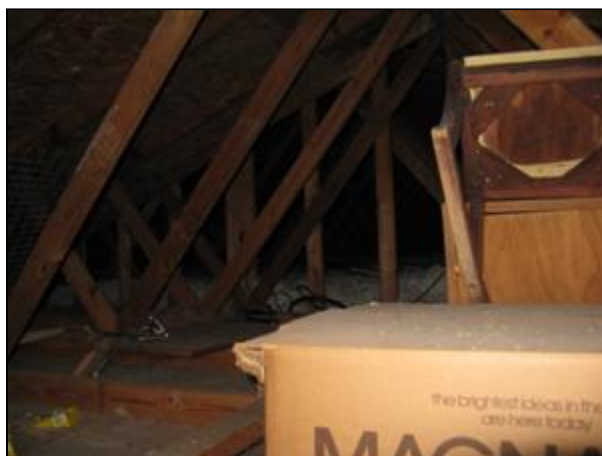
9.0 Picture 2

**9.0 (3)** Parts of the attic above the attached garage were not visible due to stored personal items.
